MINTON, TREHARNE
& DAVIES GROUP

METALLURGY & MATERIALS SCIENCE

DIVISIONAL OVERVIEW

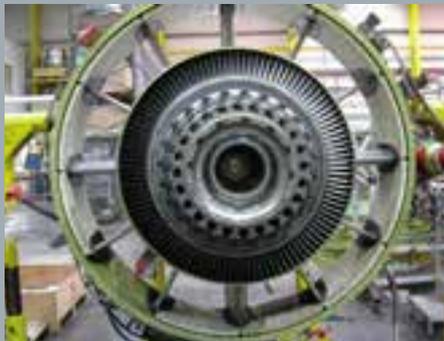
The engine booster ready for inspection

MTD were asked to investigate damage to turbine blades within an engine booster; this damage was located after removal of the engine from service and static testing. Work commenced with an on-site inspection recording the location, nature and severity of the blade damages, taking samples of residues and using black (ultraviolet) light to check for evidence of bird strikes. In the laboratory we analysed the samples using a variety of techniques to ensure that we could cross reference our results so as to exclude secondary contamination since the incident.

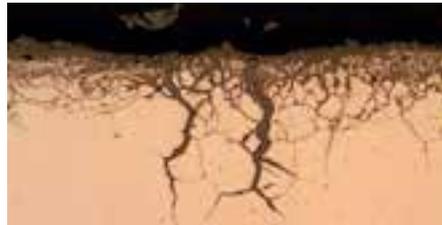
Surface changes and associated cracking

Non destructive Inspection found widespread cracking in the flares, metallurgical inspection revealed that the internal metallic surfaces of the flares had undergone significant changes in service due to absorption of carbon.

It was determined that long term use of the flares with a low flow of gas had enabled burning in areas not designed for long term use, this had resulted in changes to the metal, embrittlement and cracking.

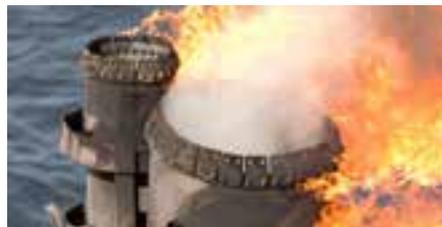
Gas burning around, not inside the flares

The materials used in gas flares are highly specialised alloys, designed to resist the intense heat of flares, and the chemical residues resultant from burning gas. The cracking had resulted in gas leaking out and burning around the flare stacks, rather than above them.

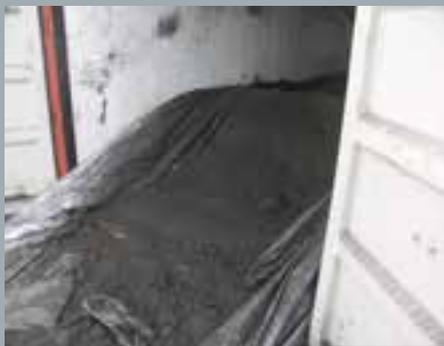
Contaminated concentrate

An international mining company was faced with a problem when several large export orders of gold and copper concentrate were tainted with foreign materials due to criminal activity. Whilst the concentrates were initially viewed as unsaleable, MTD were brought in to investigate. Site surveys in Africa and China determined that the contamination was discrete, not throughout the shipments. This was confirmed by laboratory analysis, which

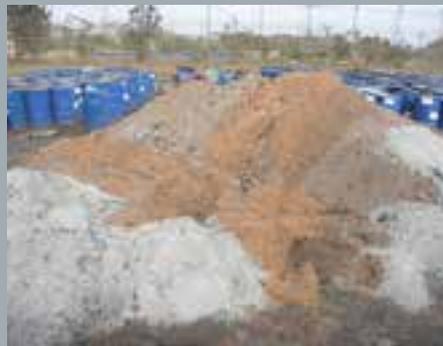
Contaminants removed from the concentrate

also provided evidence as to the nature of the contaminants. On the basis of this work a remediation strategy was developed to separate out the contaminants and recover the concentrate. MTD oversaw the setting up of a recovery operation in East Africa which successfully separated the contaminants and the original concentrate. This sorting operation proved so successful that the recovered concentrate was sold as normal, prime, quality material with no loss in value.

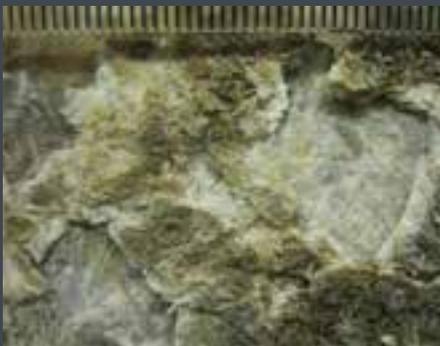
Composite surface degraded due to chemical attack

Laboratory evaluation (including mechanical and thermal analysis) of composite samples found evidence for poor construction and in service degradation of the resin and fibres in the composite. This enabled us to conclude that the composites were in a damaged state due to long term degradation, and as such this was unrelated to the blast.

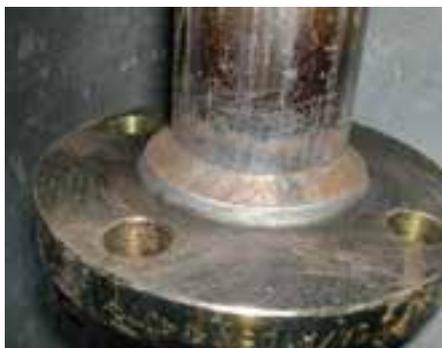
Small bore pipe to flange weld

MTD provided expert support and testing services in the investigation of widespread cracking and failure of small bore welds in a gas processing facility. This involved the sectioning, testing and assessment of over 1,000 welds in a very tight time frame. The data generated by our testing enabled us to reach a definitive conclusion that the cracking was due to hydrogen embrittlement associated with sulfide

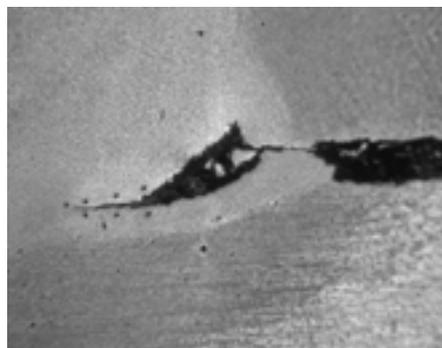
Defective weld cross section

stress cracking (SSC) due to poor welding, not in accordance with approved weld procedures. The welds we examined showed that the facility still contained many welds susceptible to this failure mechanism and, hence, that further failures could be expected in future. A major programme of refurbishment was undertaken to remove or remediate the bad welds.

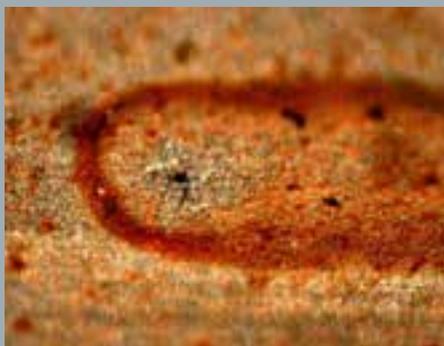
Pinhole corrosion pit inside a pipe

MTD were appointed to investigate a systemic corrosion problem affecting the stainless steel hot water systems in cruise ships. The corrosion had resulted in pinholes and leaks throughout the ships, with consequent water damage. The cause of the problem had to be swiftly ascertained as the ships involved were due to be shortly sold at auction. We surveyed the vessels and selected samples for laboratory investigation. Our survey revealed that

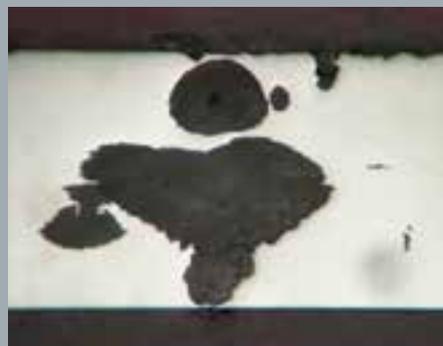
Cross section through pinhole revealing large underlying corrosion pits

the problem was more widespread than previously determined and that further failures were imminent. Our analysis revealed that corrosion was due to an inherent mismatch between the grade of stainless steel used in the hot water system and the quality of water produced in the vessel. However the incipient damages could not be rectified by a change in water chemistry and full replacement of the pipework was advised.

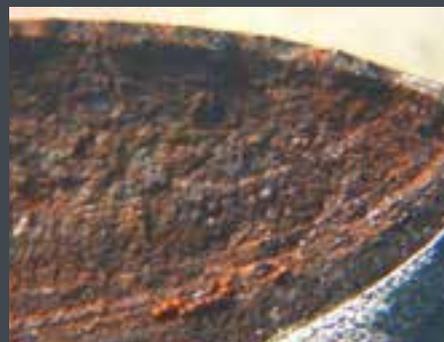
A fatigue crack propagating top to bottom through the pipe

A subsea pipeline failed in at a welded joint soon after entering service. This was initially blamed on abnormal stresses during installation, but further investigation was deemed appropriate. MTD were sent samples from the failed weld for analysis, as well as full manufacturing records. Analysis of the welded joint found that cracks had propagated through the pipe from the weld toes (the weld edges) by fatigue; various small manufacturing defects were also

found in the weld. Study of our results and comparison with manufacturing records revealed that the manufacturer's quality control had not detected these defects. More importantly we also determined that the pipe on one side of the weld did not correspond to quality records, and was made from a material 40% weaker than specified. FEA (Finite Element Analysis) Modelling revealed that normal bending loads during installation could produce overload and cracking.

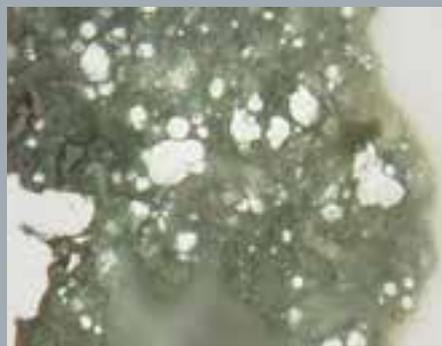
Zinc in the coating as applied

the coating and found evidence for poor surface preparation and failure to follow specified application parameters, however our most important finding was that the first paint layer contained much less zinc than specified. The absence of sufficient zinc meant that if the coating was breached there was no local galvanic protection, and corrosion could undercut the coating and lift it off the underlying steel.

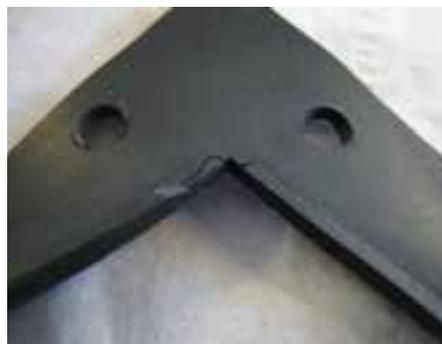
Cracks in the gasket edges

analysis techniques (including TGA, FTIR, GCMS and EDX) on the gaskets and the oil to investigate both the qualities of the original material and the reason for degradation. Our investigations determined that the grade of rubber supplied was not consistent with that specified, and in service had absorbed the transformer oil, and subsequently degraded.
